Dogfish Head Brewings & Eats

Acoustic Treatment Recommendations

Cameron Girard - Acoustic Design Consultant

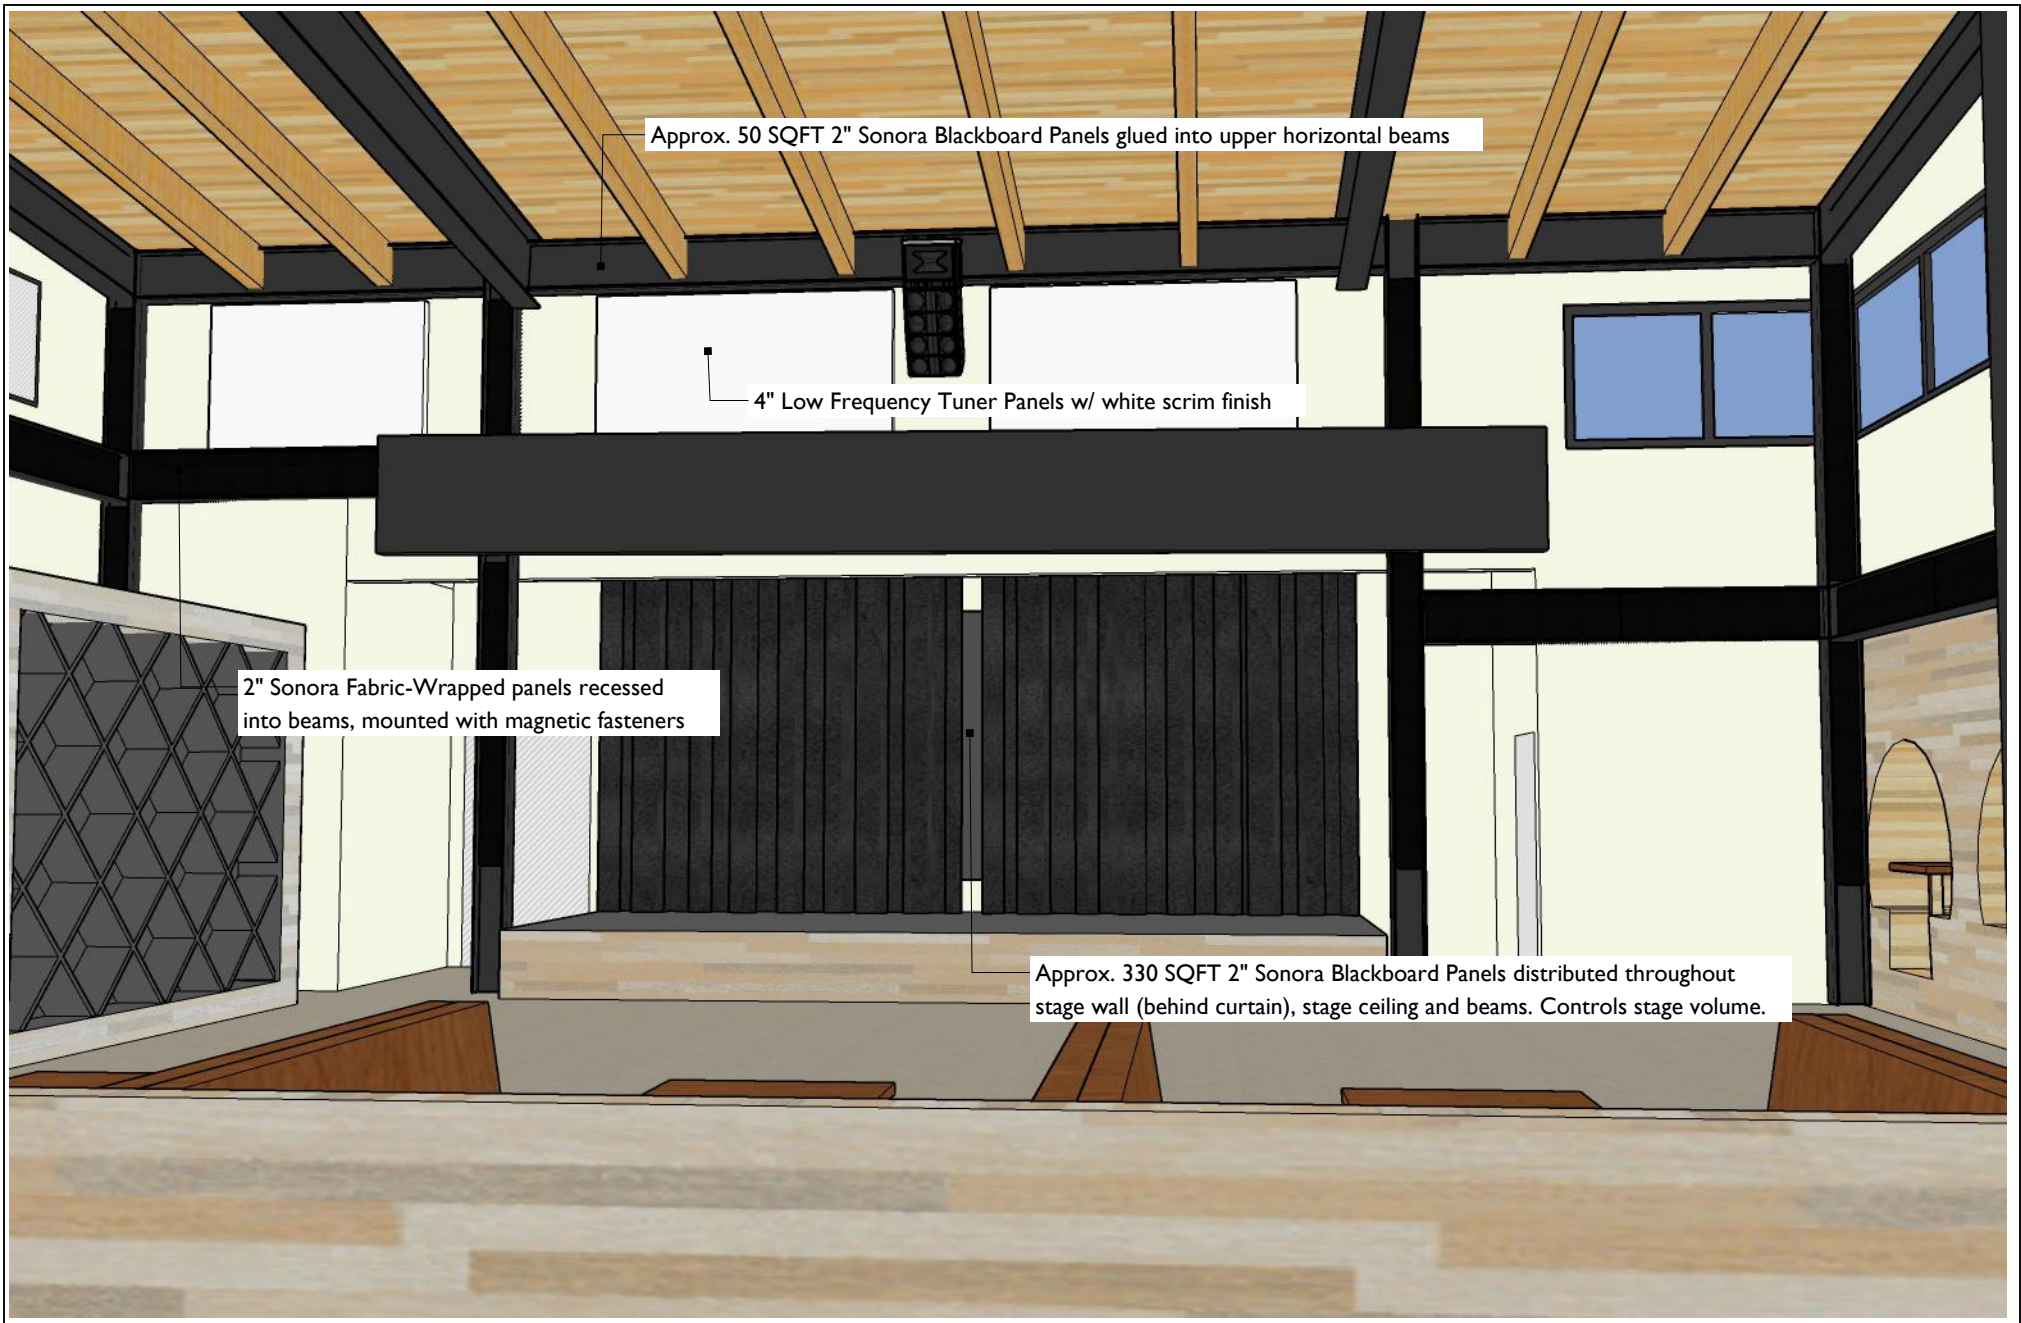
Approx. 50 SQFT 2" Sonora Blackboard Panels glued into upper horizontal beams

4" Low Frequency Tuner Panels w/ white scrim finish

2" Sonora Fabric-Wrapped panels recessed into beams, mounted with magnetic fasteners

Approx. 330 SQFT 2" Sonora Blackboard Panels distributed throughout stage wall (behind curtain), stage ceiling and beams. Controls stage volume.

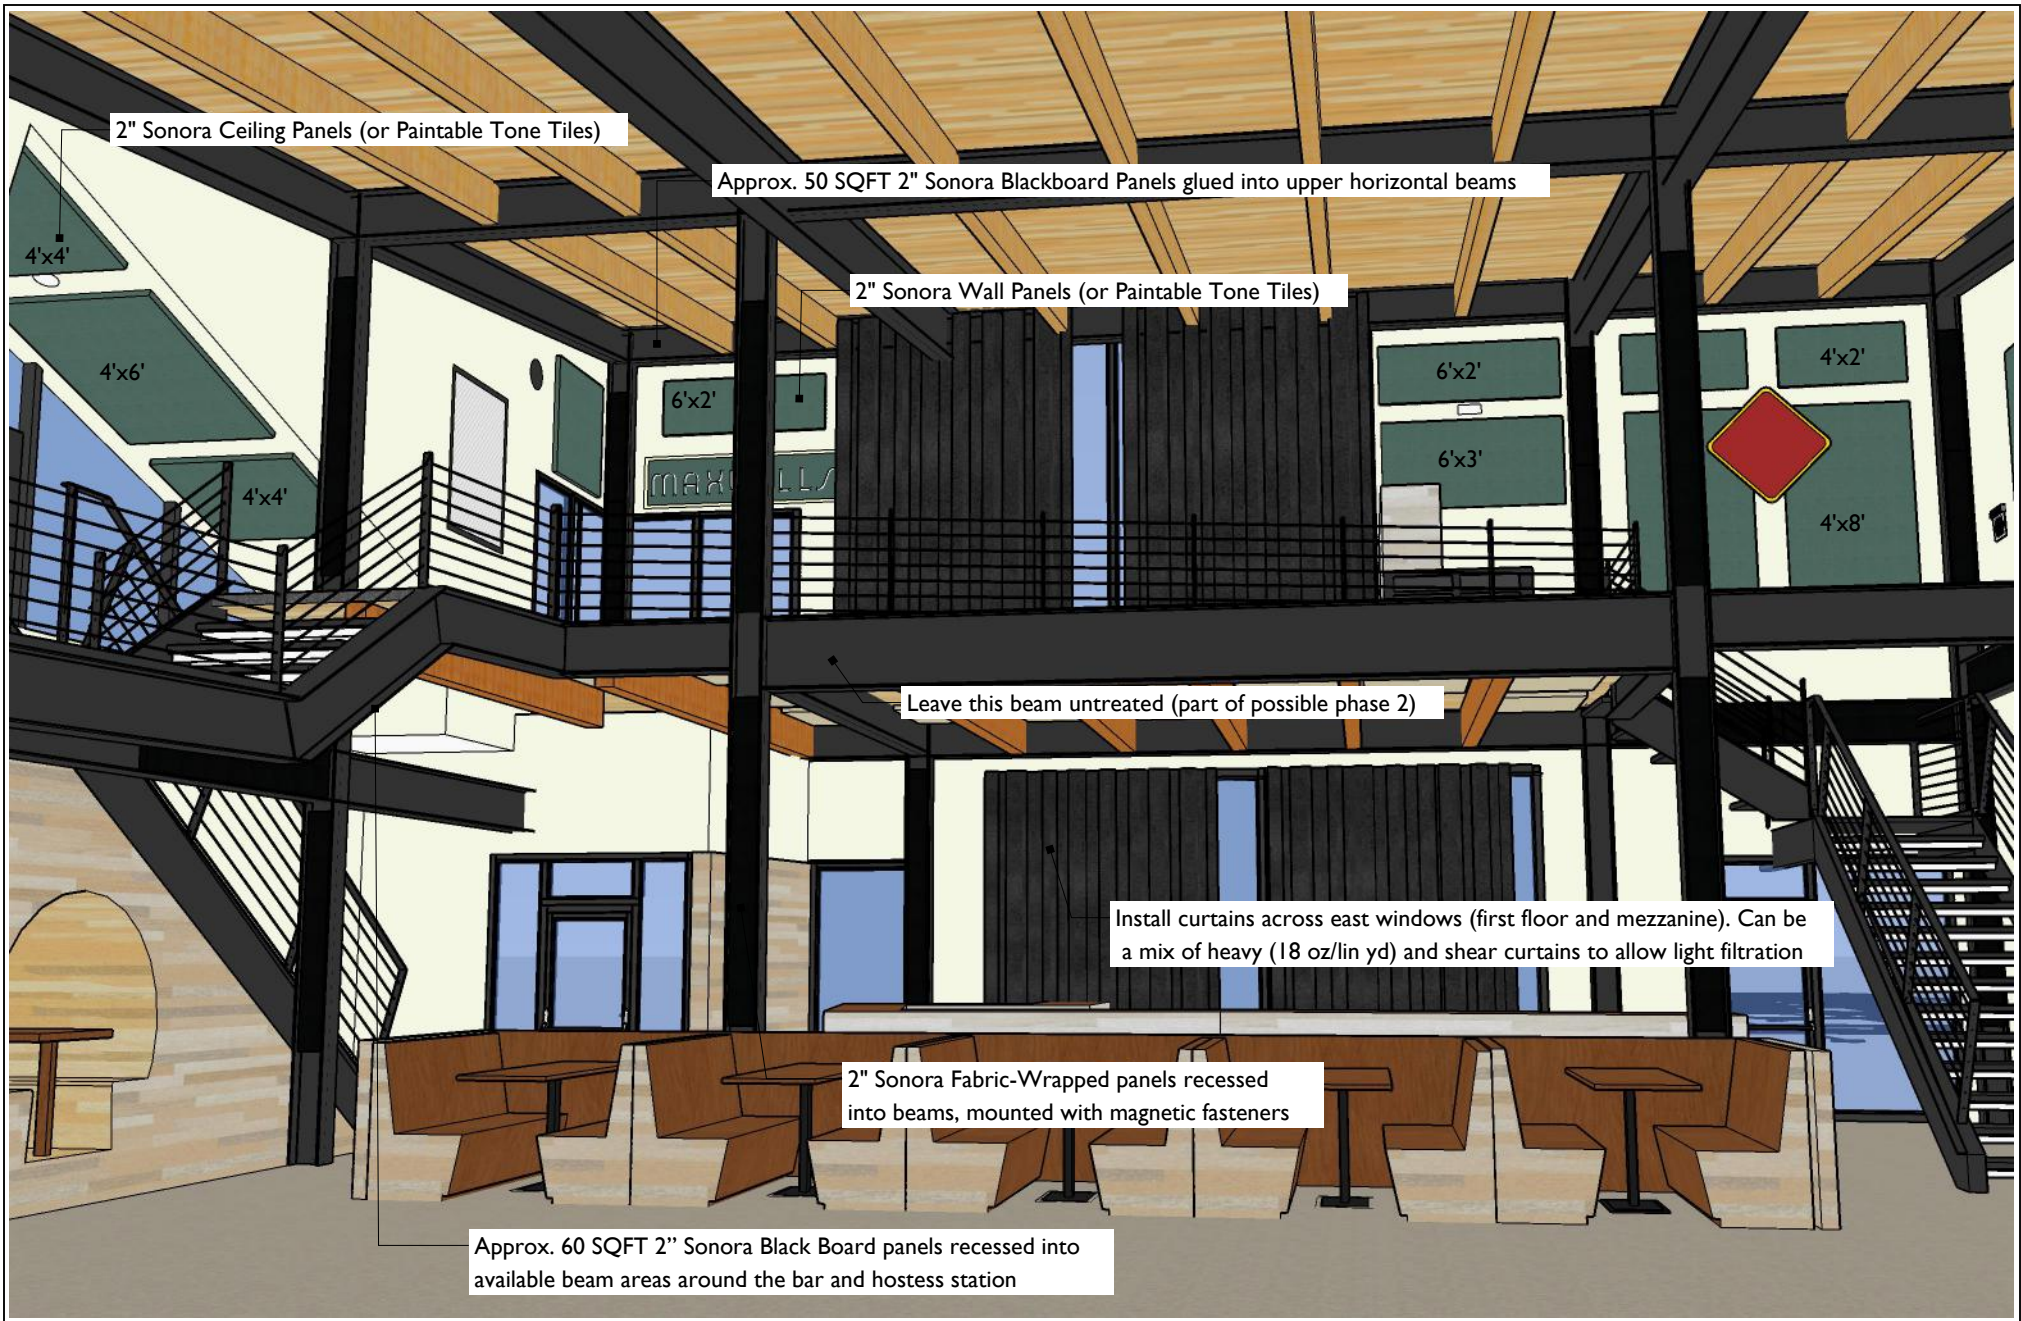
A 03

2" Sonora Ceiling Panels (or Paintable Tone Tiles)

Approx. 50 SQFT 2" Sonora Blackboard Panels glued into upper horizontal beams

2" Sonora Wall Panels (or Paintable Tone Tiles)

Leave this beam untreated (part of possible phase 2)

Install curtains across east windows (first floor and mezzanine). Can be a mix of heavy (18 oz/lin yd) and shear curtains to allow light filtration

2" Sonora Fabric-Wrapped panels recessed into beams, mounted with magnetic fasteners

Approx. 60 SQFT 2" Sonora Black Board panels recessed into available beam areas around the bar and hostess station

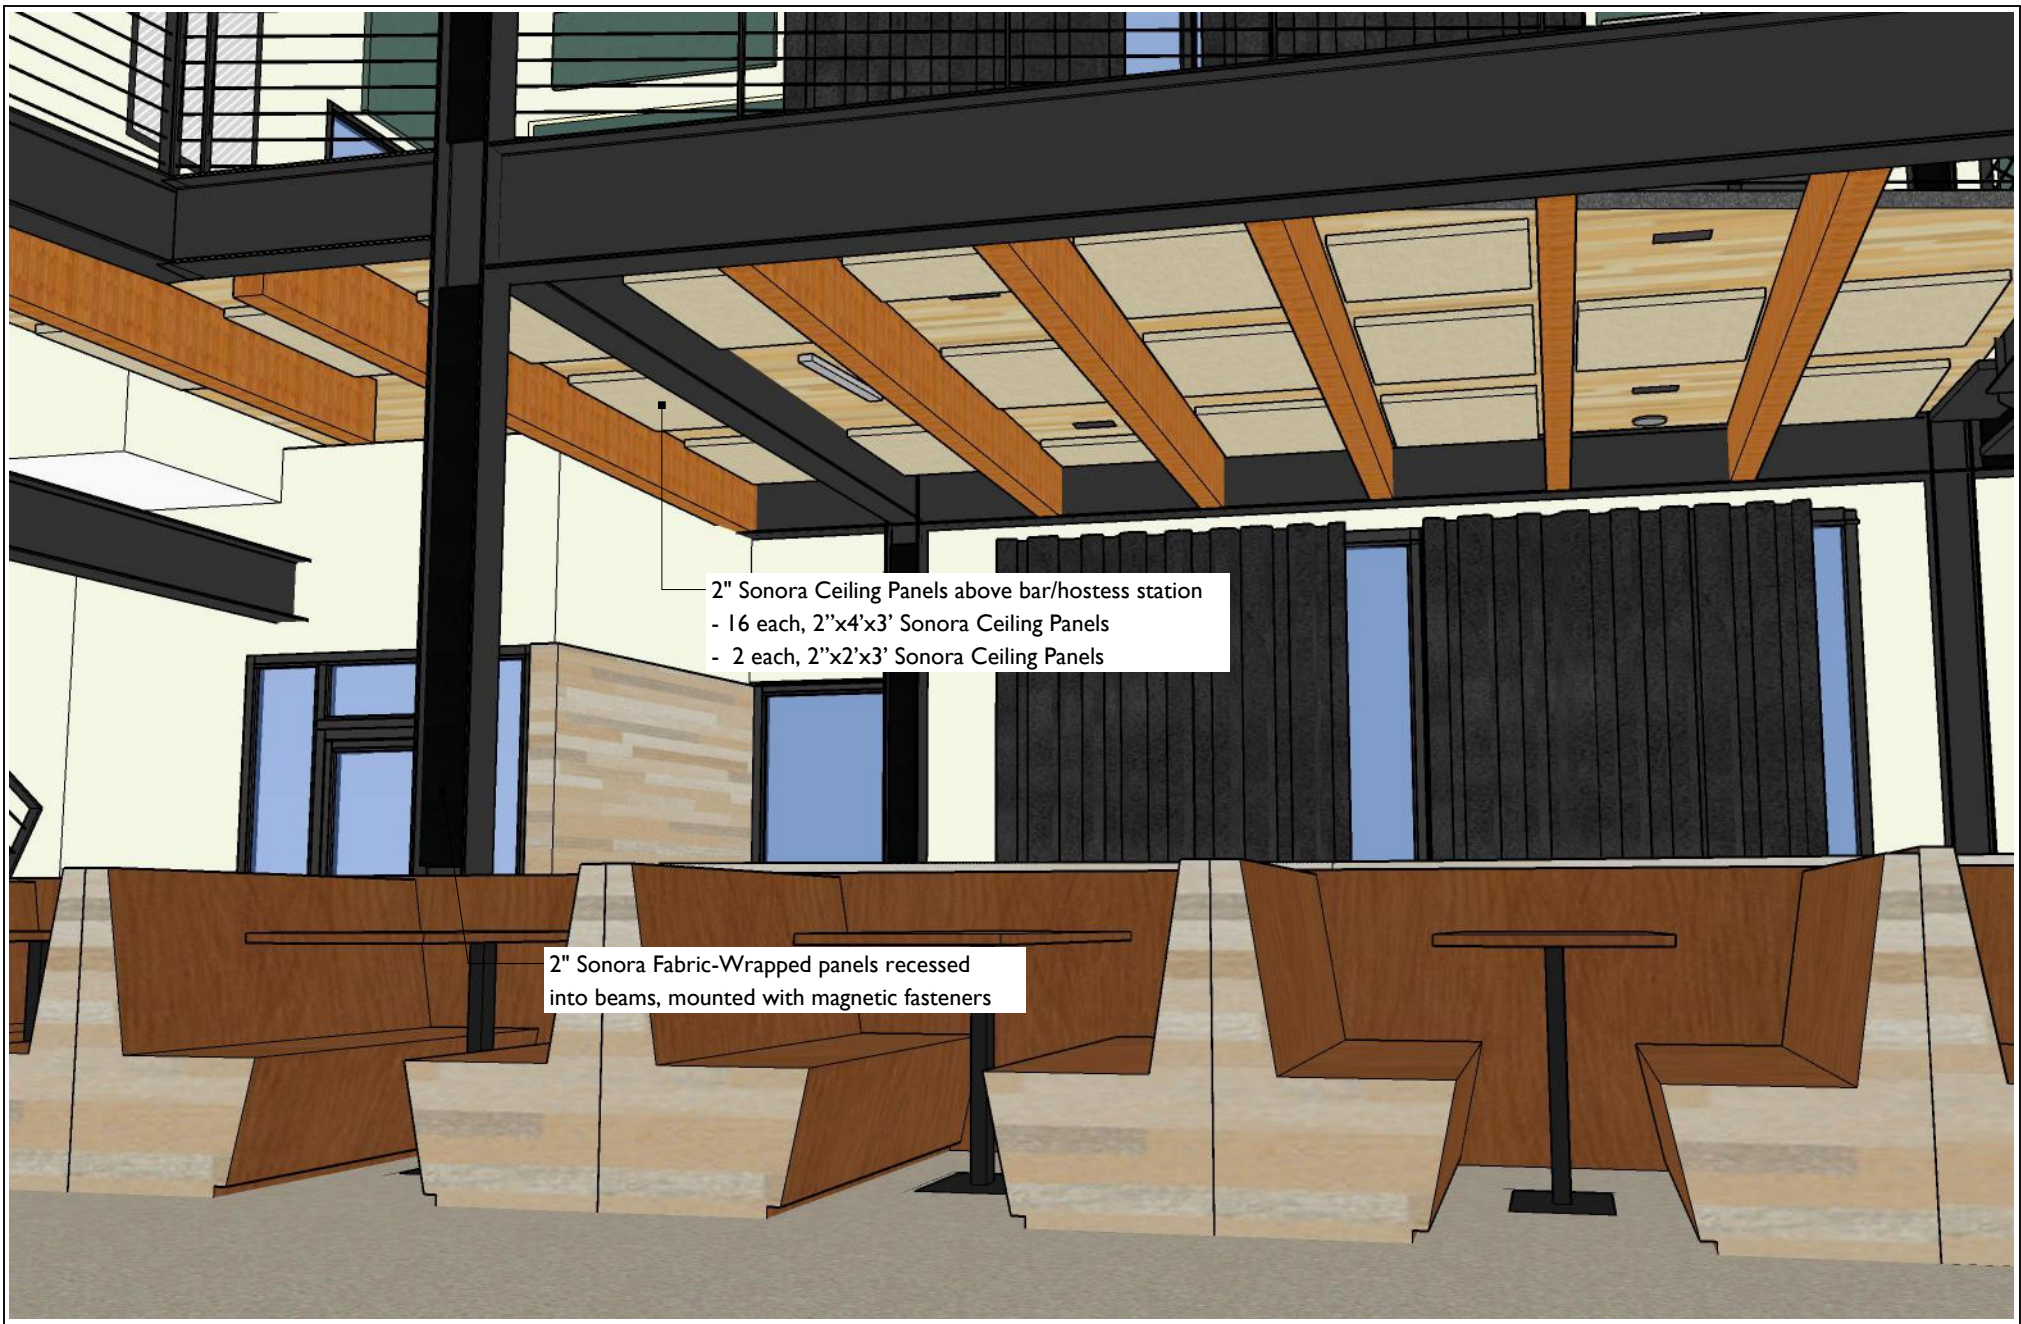
2" Sonora Ceiling Panels above bar/hostess station
- 16 each, 2"x4'x3' Sonora Ceiling Panels
- 2 each, 2"x2'x3' Sonora Ceiling Panels

2" Sonora Fabric-Wrapped panels recessed
into beams, mounted with magnetic fasteners

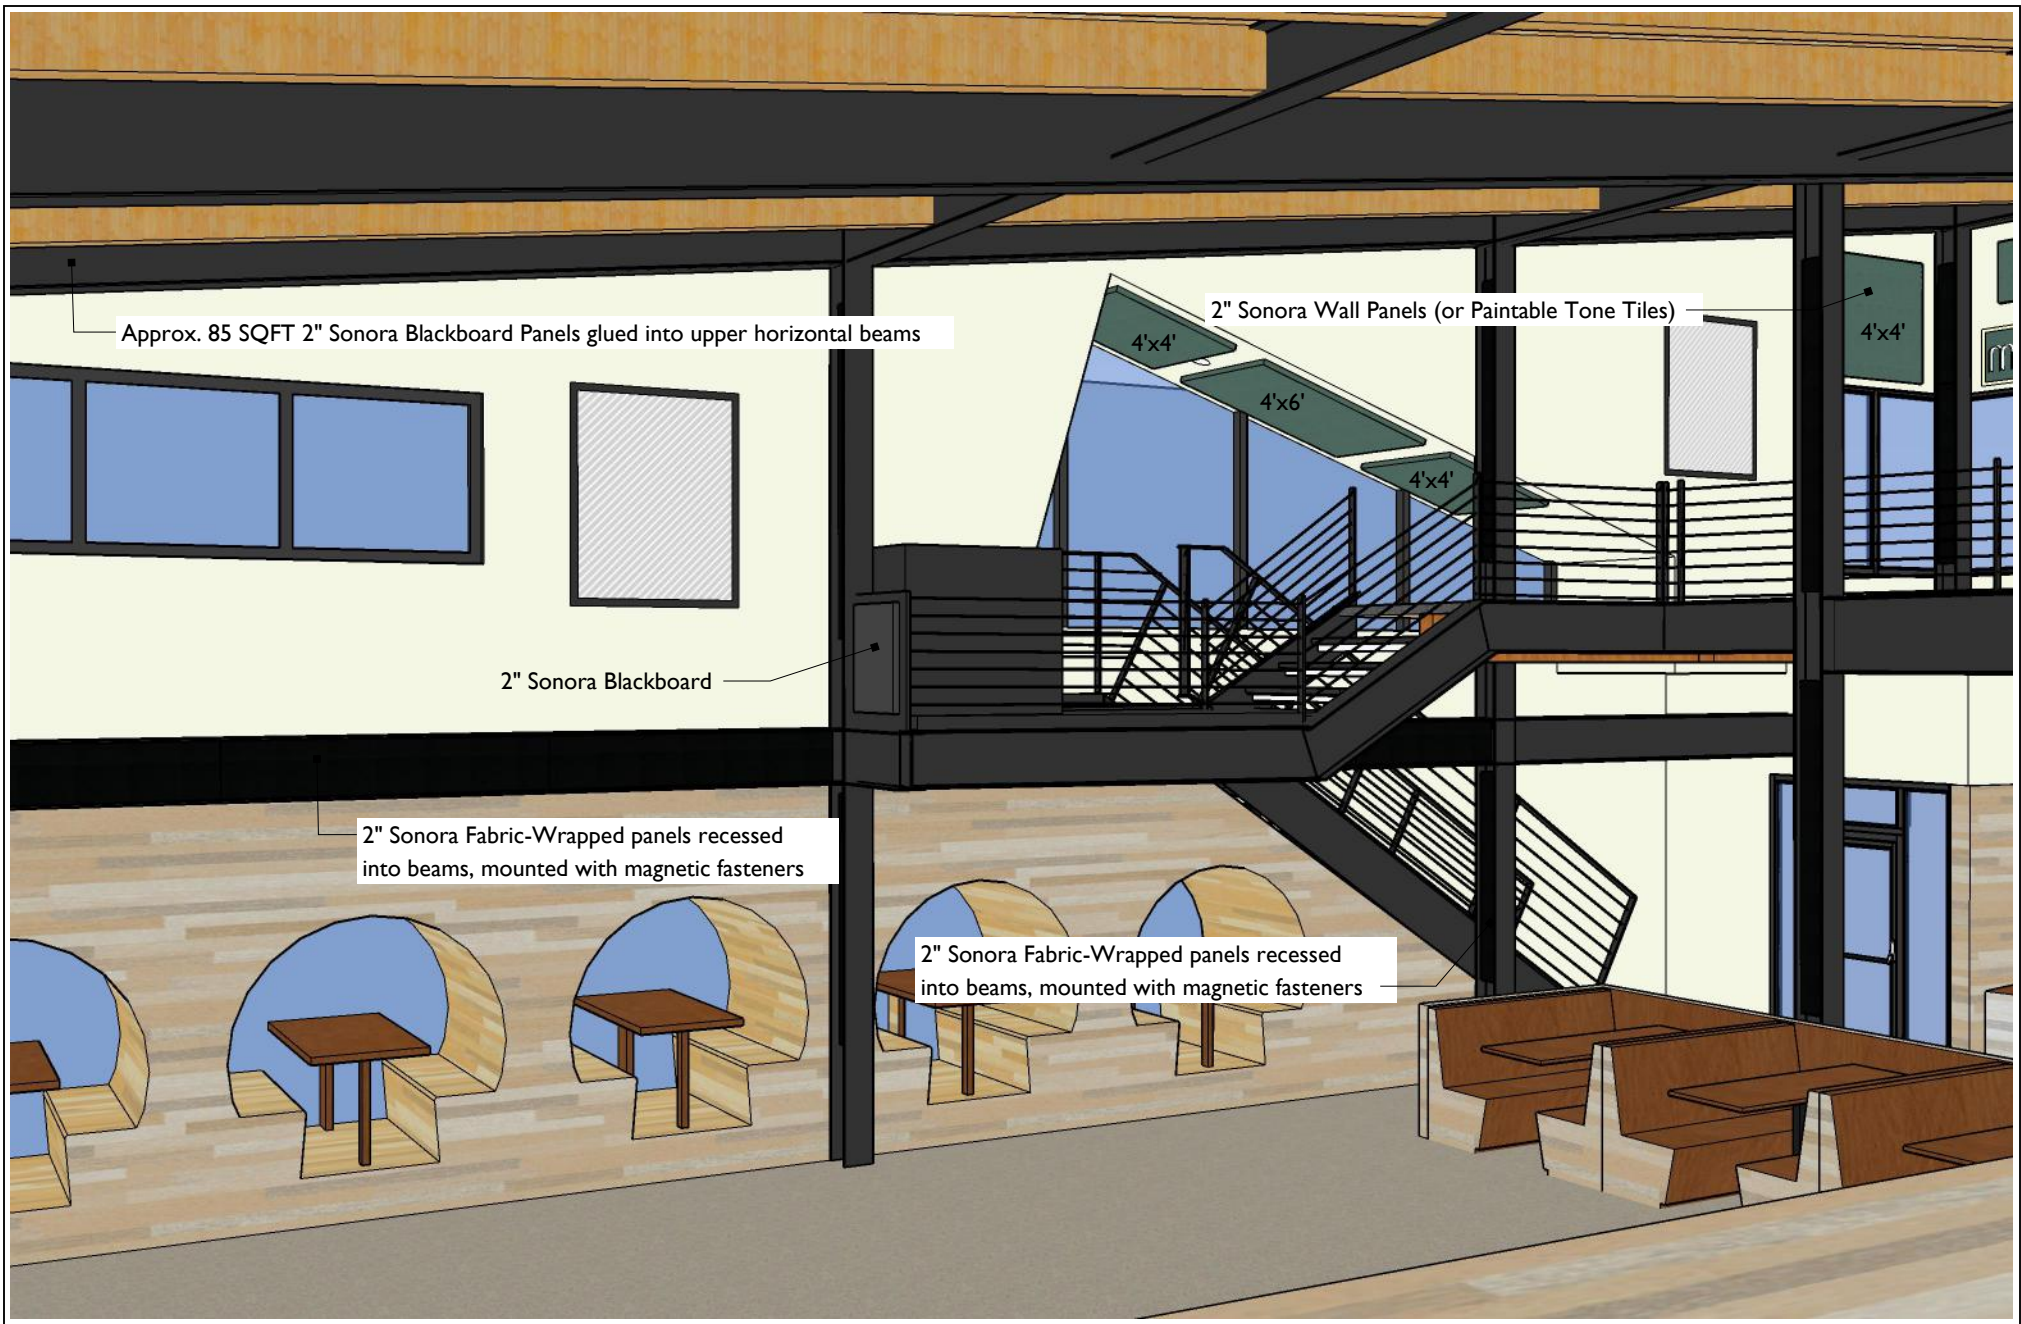
Approx. 85 SQFT 2" Sonora Blackboard Panels glued into upper horizontal beams

2" Sonora Wall Panels (or Paintable Tone Tiles)

2" Sonora Blackboard

2" Sonora Fabric-Wrapped panels recessed into beams, mounted with magnetic fasteners
